RISS LAKE DAM

MO 20128

PHASE 1 INSPECTION REPORT
NATIONAL DAM SAFETY PROGRAM

PREPARED BY: HOSKINS-WESTERN-SONDEREGGER, INC.

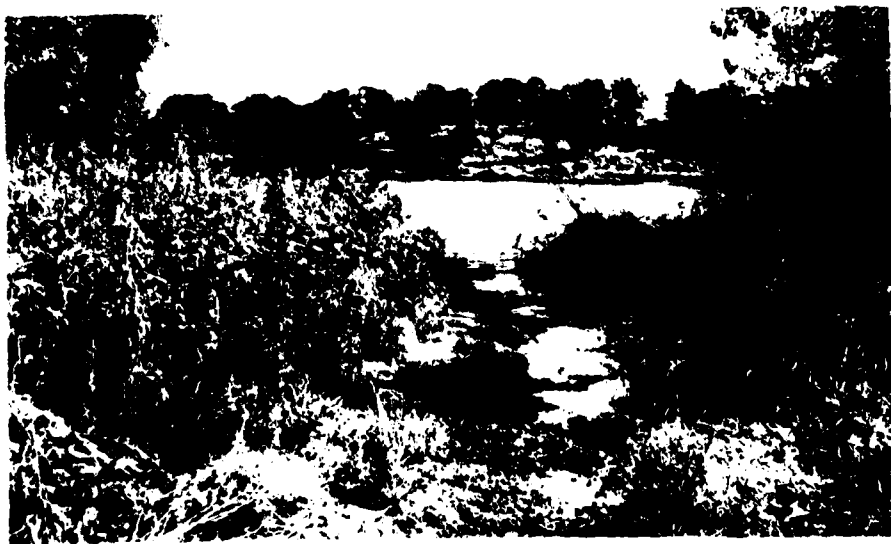
- c. Appurtenant Structures. The spillway consists of an earth channel, with a broomed concrete invert, that drops sharply down the left abutment. The spillway channel follows the route of the original spillway channel, but the flowline has eroded up to 20 feet vertically at some locations. The original limestone masonry walls of the spillway channel remain, generally intact, high above the existing flowline. It was reported that head-cutting erosion of the spillway channel began shortly after construction and reached the dam during high flows in 1977. At that time, erosion of the channel lowered the lake level about 7 feet. The spillway was then repaired in order to bring the lake back to its normal level. A plug of compacted soil was constructed in the eroded spillway channel. The plug is about 100

feet long, gently sloping on top, and steeply sloping on the downstream side. The concrete spillway invert is constructed on this earth plug and stops when it reaches the eroded spillway channel. At station 2+80 there is an 8-inch steel siphon that has been installed as a drawdown works. The intake is reported to be about 20 feet below the normal pool level. Where the siphon passes through the embankment, its top is at the normal pool level. After emerging from the embankment, the pipe rests on the downstream slope with an unprotected discharge about 30 feet below the downstream toe. The siphon was carrying no flow at the time of the inspection. The uncontrolled spillway and the drawdown siphon are the only structures to control pool levels at this dam.

PHOTO NO. 9
LOOKING UPSTREAM
IN SPILLWAY
